New Zealand Aquatic
Environment and Biodiversity
Report No. 24
2008
ISSN 1176-9440

Electronic monitoring to assess protected species
interactions in New Zealand longline fisheries:
a pilot study

Howard McElderry
Jessica Schrader
Simon Anderson

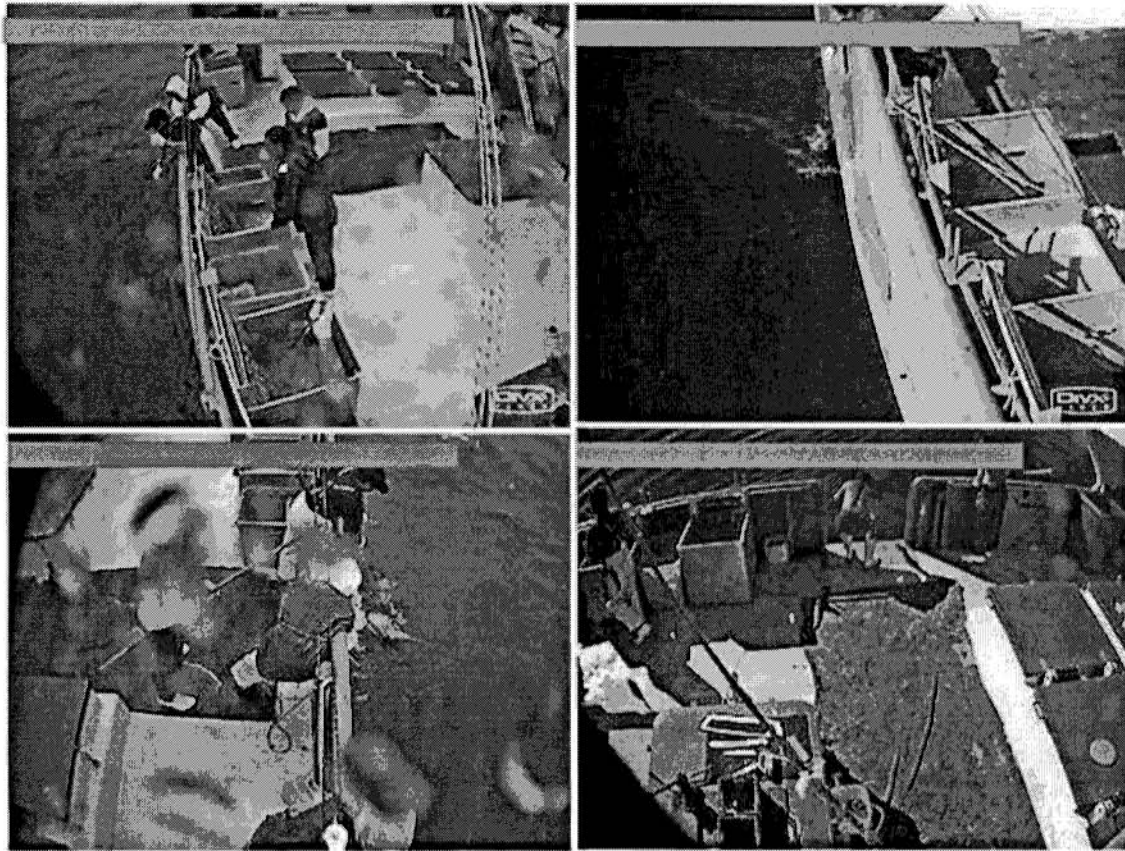
Figure 10: CCTV camera views from Vessel 3, showing initial camera view (left) and changed view (right).

Changes in camera positions on Vessel 3 were more significant (Figure 10). Both hauling station cameras were repositioned after the first trip in an effort to improve the view of the sea door where catch was typically brought aboard. In one case the camera position was extended further outboard and the lens magnification increased (Figure 11, upper). This change significantly improved the view of the crewmember working at the hauler and of catch approaching the sea door. The second bridge mounted camera, providing a forward view of the hauling station, was repositioned to the port side

showing the forward deck area where catch was brought aboard. While this camera angle improved the view of catch landed on board, it was at the expense of the outboard view. Imagery outboard and aft of the sea door was lost.

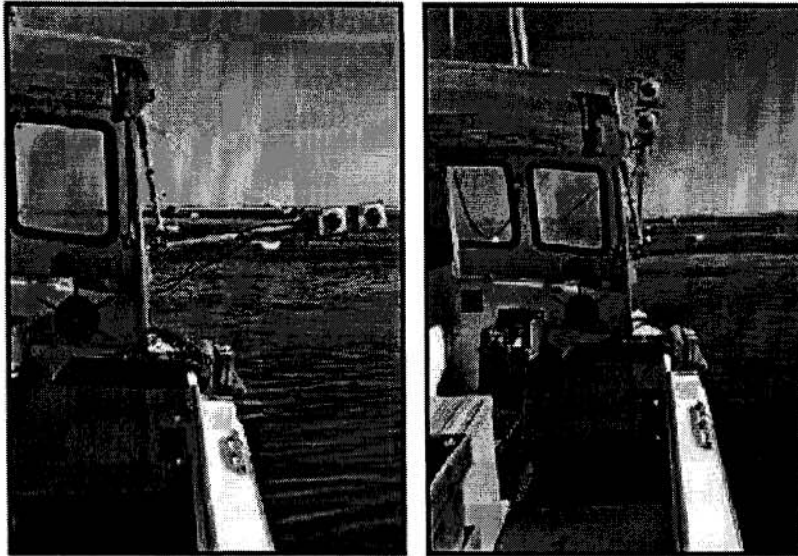
Figure 16: Movable camera mount used on a small longline vessel on the east coast of the US (from McElderry et al. 2007a).

A final issue concerning technical suitability of EM for these vessels concerns the placement of cameras. On all four vessels camera placement was opportunistic, using existing standing structures as much as possible. In a few instances a customised camera mount pole was used to place cameras where no mounts were present. In nearly all instances the camera placements were not ideal and this affected the quality of catch information that could be obtained. Whereas many longline vessels in British Columbia have stabiliser poles that provide ideal camera mounting locations, most vessels in the New Zealand fishing fleet do not use them. Because this was a voluntary pilot study and there was little advance warning, vessel masters were reluctant to make structural modifications for this study. In future, more attention should be given to the use of custom camera mounts to properly position cameras. For example, vessels could be fitted as shown in Figure 16 with movable swing arm mounts such as has been fitted on small longline vessels operating on the east coast of the US.
